Notice is given of an Engineering and Services Committee Meeting to be held on:

Engineering and Services Committee Meeting

20 April 2021

Mackenzie District Peace Avenue Tree Report

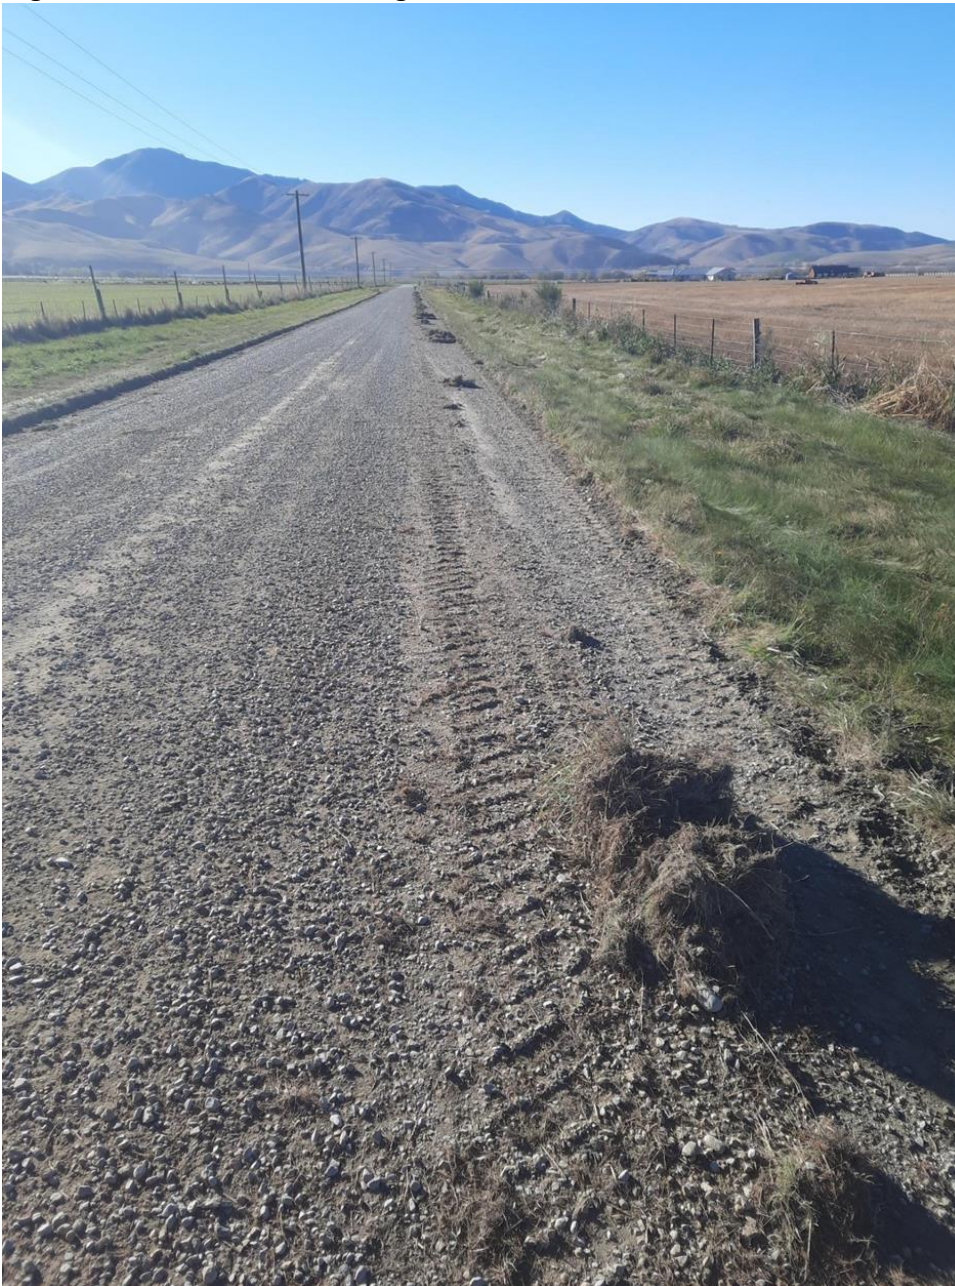
damage. There may be some interim changes in conditions over the next few months to what is typically expected. For example, as can be seen in the image below windrows of organic material left to breakdown between grading cycles which isn't visually appealing but this will return to its regular condition in the coming month

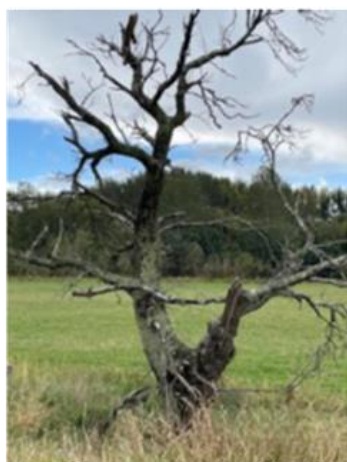
Dead Ulmus procera (English Elm) requiring removal

Stumps of one *Quercus robur* (Common Oak) and one *Ulmus procera* (English Elm) previously removed require stump grinding and berm restoration; neither of these stumps present immediate health and safety or road corridor issues.

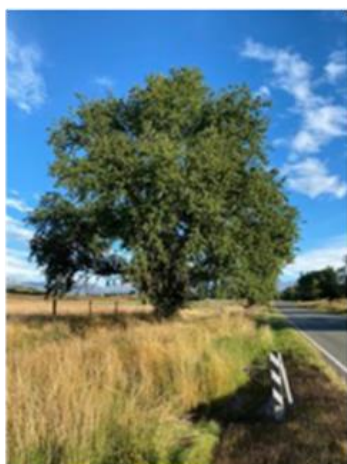
Branches starting to encroach onto road

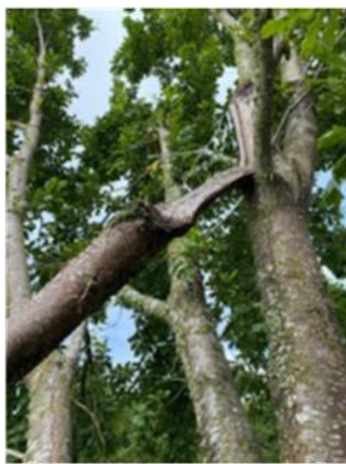
Broken main limb

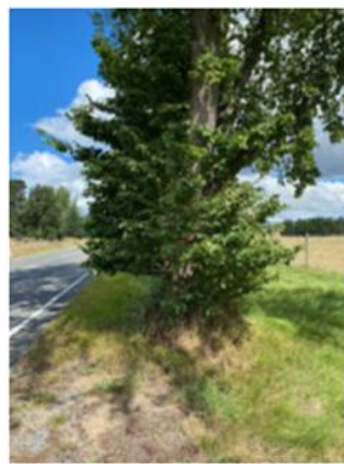
Epicormic growth near road carriageway

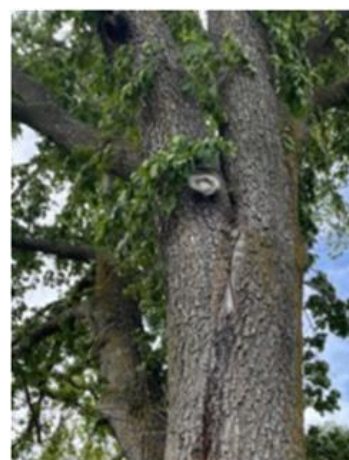
Cracking in main trunk

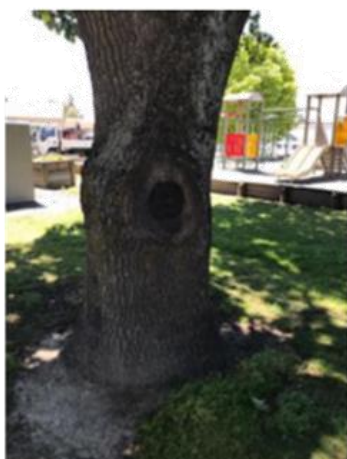
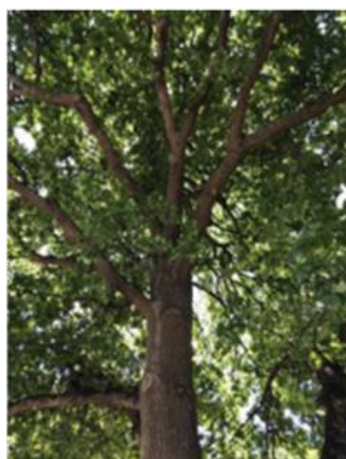
Asset ID: 3

Issue(s): Appears to have much thinner crown than trees either side of similar age. Given its location in a high profile area failure could cause significant damage (pruning recommended)

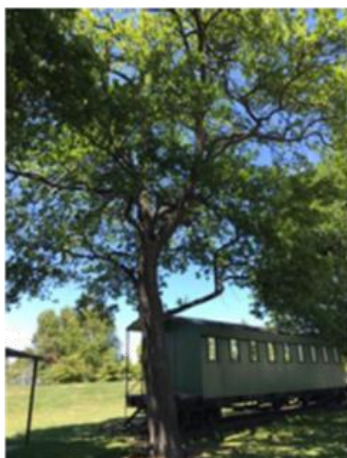
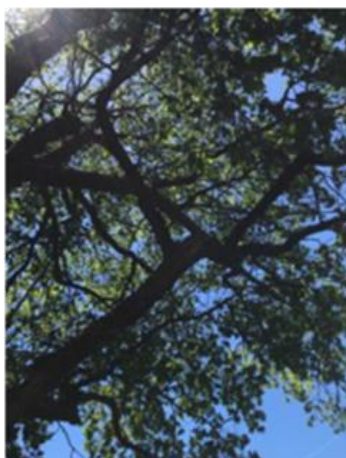
Asset ID: 4

Issue(s): Has decay in main trunk given its location next to the rail truck failure could cause significant damage (pruning recommended)

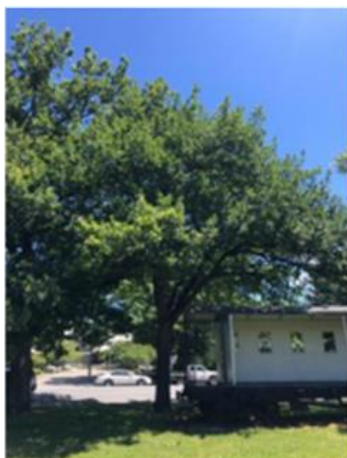
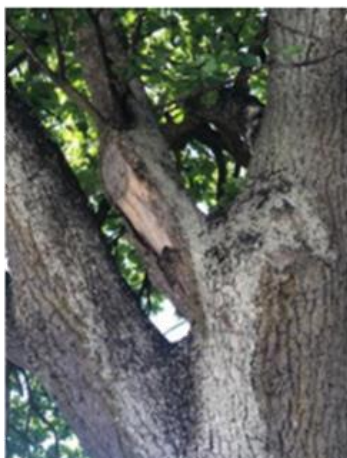
Asset ID: 5**Species:** Quercus robur (Common Oak)**Issue(s):** large deadwood and low hanging branches. Given its location in a high profile area failure could cause significant damage (pruning recommended)

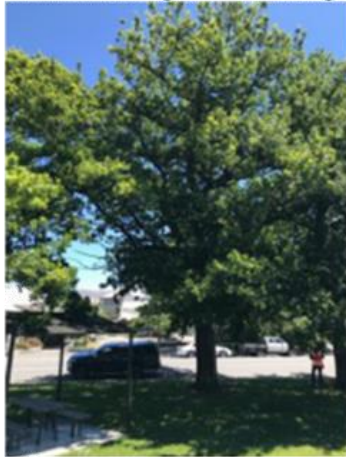
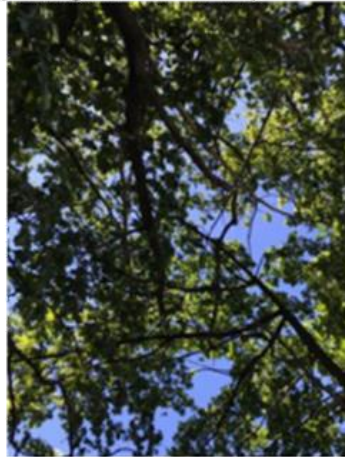
**Asset ID: 70****Species:** Ulmus procera (English Elm)**Issue(s):** Has decay and a significant wound in main trunk a where branch was lost (pruning recommended)

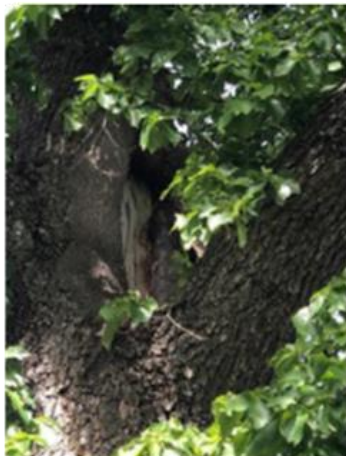
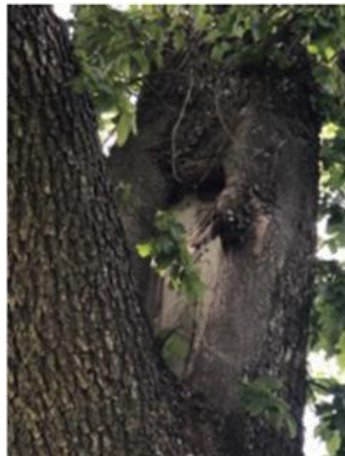
Asset ID: 72

Issue(s): Has lost a large limb which has resulted in damage to trunk tree (pruning recommended)

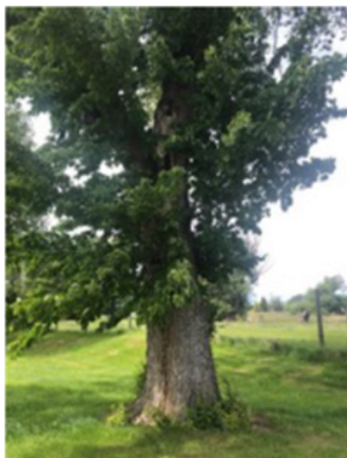
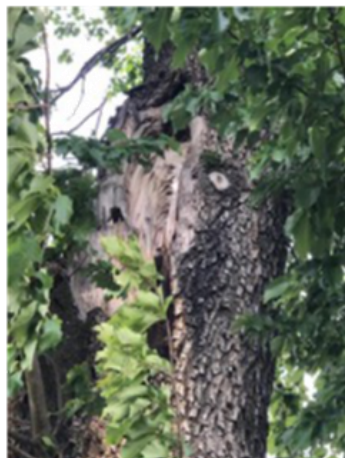
Asset ID: 73

Issue(s): Has split in fork of main branch, (pruning/weight reduction recommended)

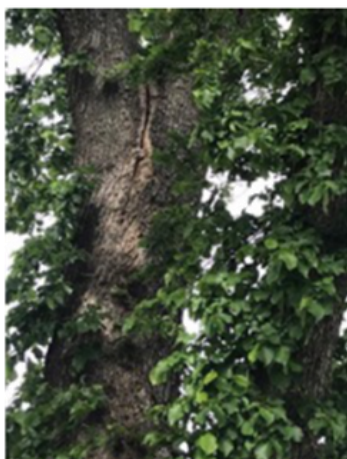
Asset ID: 470

Issue(s): Split in main trunk causing weakness don't believe weight reduction will address issue.
(removal recommended)
